# SERVICE BULLETIN

Classification: EC05-017a	Reference: NTB06-004a	Date: April 3, 2007
------------------------------	--------------------------	------------------------

## MIL 'ON' WITH DTC P0420: CATALYTIC CONVERTER IS UNDAMAGED

**APPLIED VEHICLES:** 2004-2006 Altima (L31)

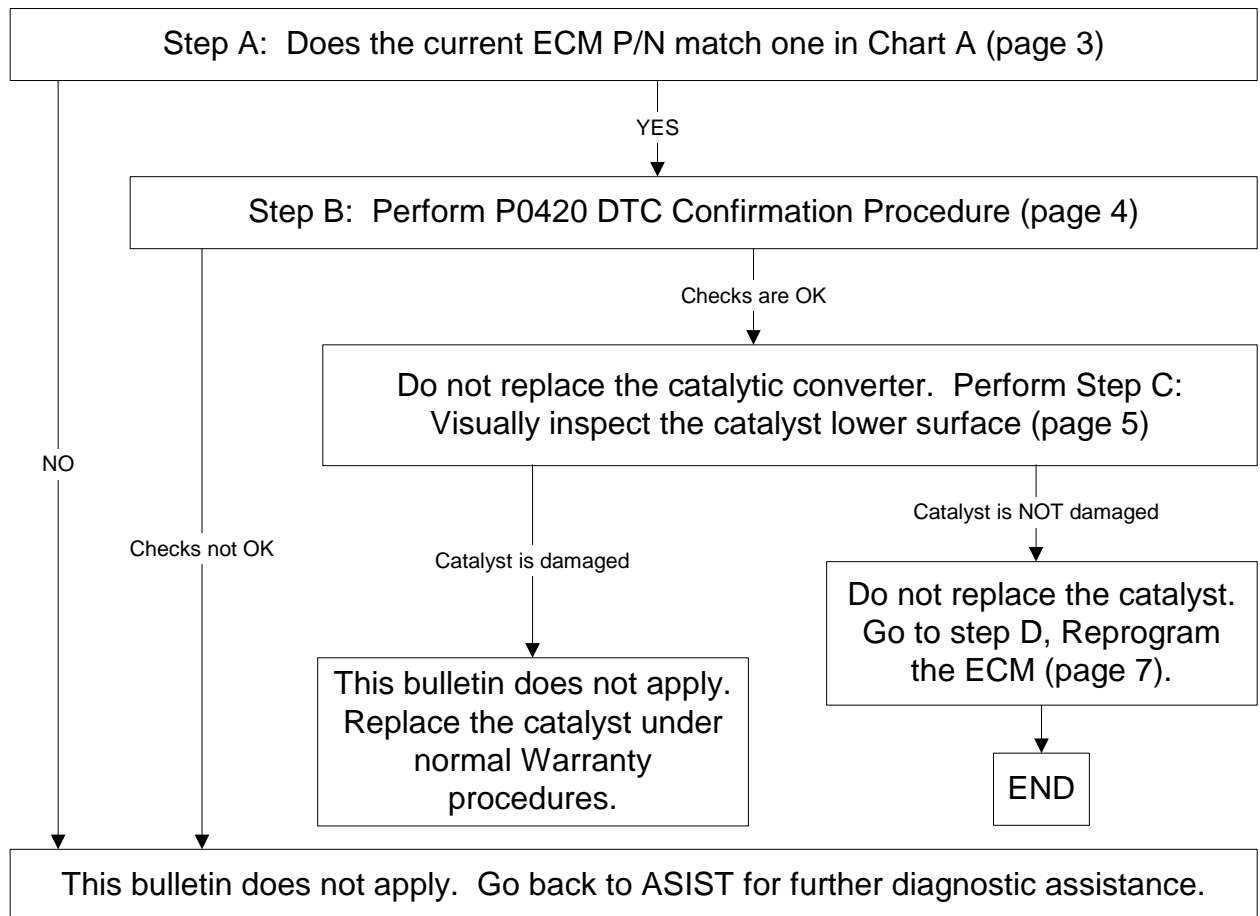
## DIAGNOSTIC FLOWCHART

NOTE: This bulletin and the associated reprogramming only apply to vehicles with undamaged three way catalyts.

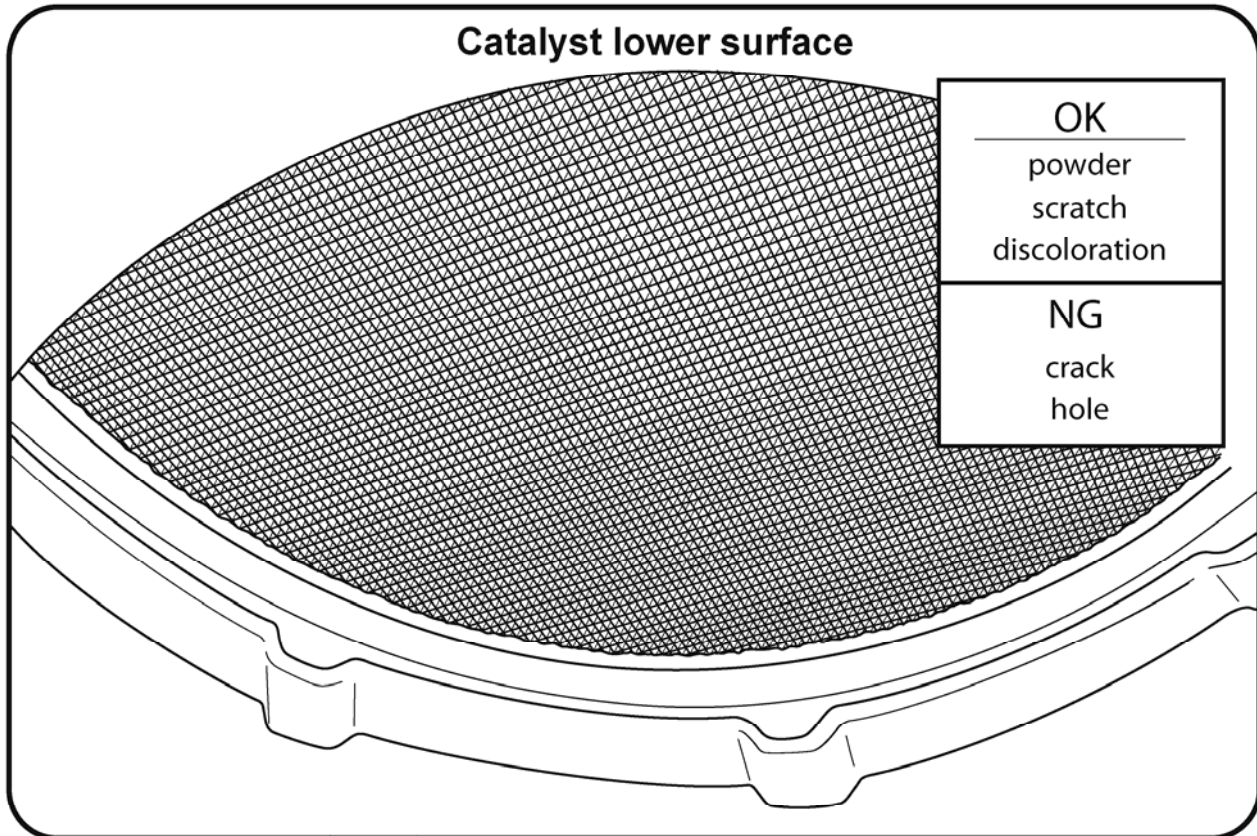
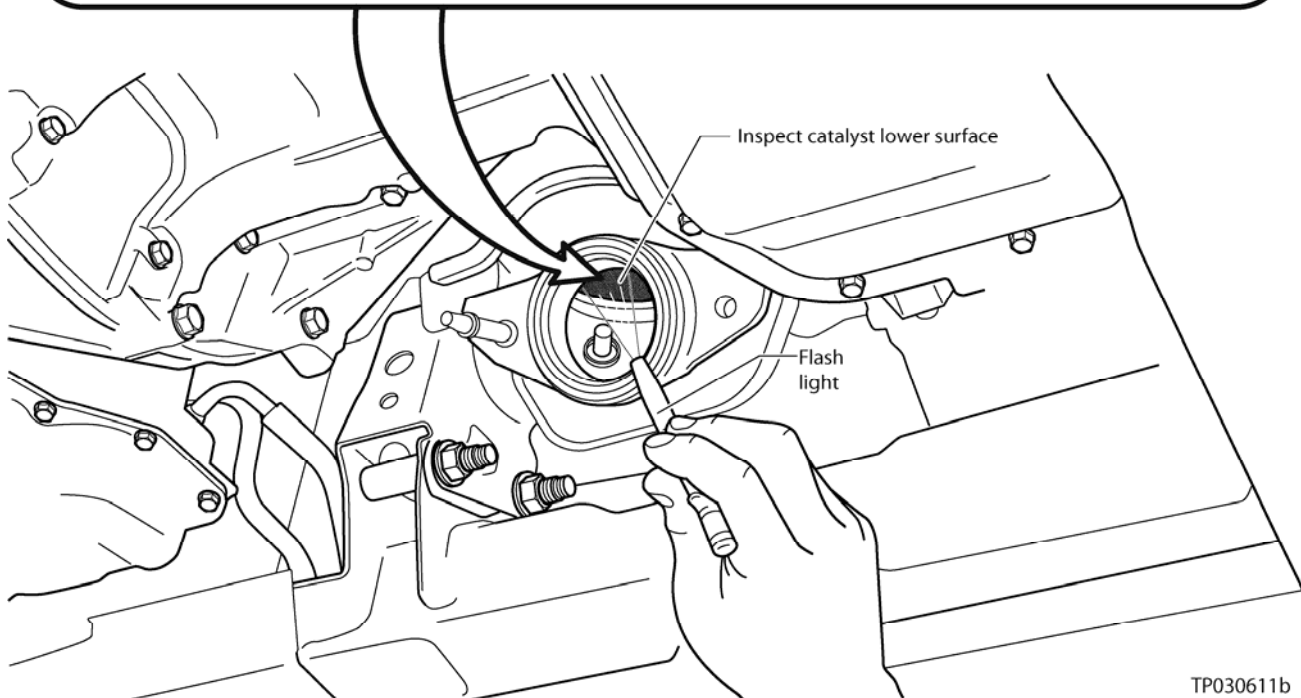
Figure 4

7. Inspect the entire catalyst lower surface condition as shown in Figure 4.

**IMPORTANT:** Make sure you inspect the entire lower surface. You are looking for cracks or holes in the lower surface.

- If the catalyst is NG with cracks or holes. Replace the catalyst using standard Warranty procedures. This bulletin does not apply.
- If the catalyst is OK with only powder, scratch or discoloration **do not replace the catalytic converter**, reassemble the vehicle in the reverse order of disassembly and go to step D.
