# SERVICE BULLETIN

Classification: EC05-017a	Reference: NTB06-004a	Date: April 3, 2007
------------------------------	--------------------------	------------------------

## MIL 'ON' WITH DTC P0420: CATALYTIC CONVERTER IS UNDAMAGED

**APPLIED VEHICLES:** 2004-2006 Altima (L31)

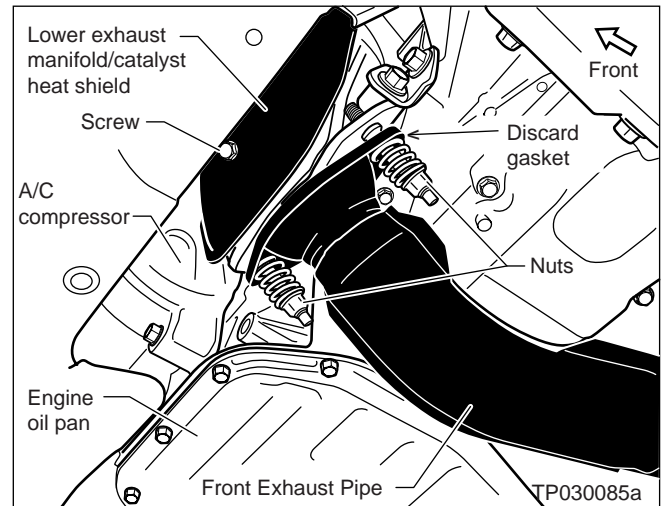
Figure 1

1. Remove the two nuts that hold the front exhaust pipe to the exhaust manifold /catalyst (see Figure 1). Discard the old gasket. Replace with a new gasket during reassembly.

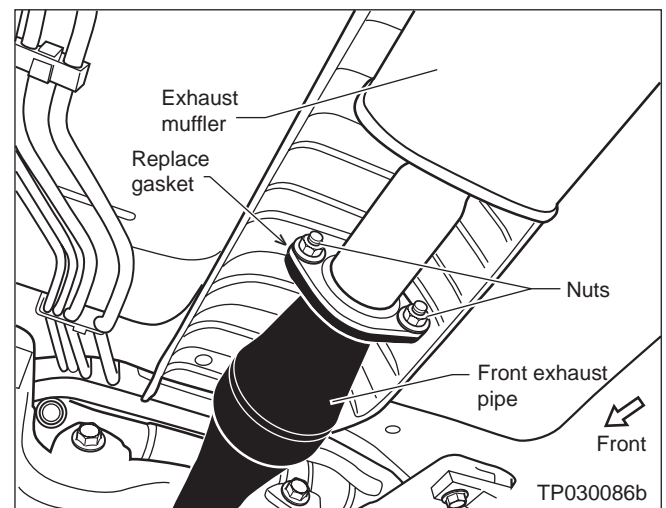
Figure 2

2. Remove the two nuts that hold the front exhaust pipe to the muffler (see Figure 2). Then, separate the front exhaust pipe from the muffler. Discard the old gasket. Replace with a new gasket during reassembly.

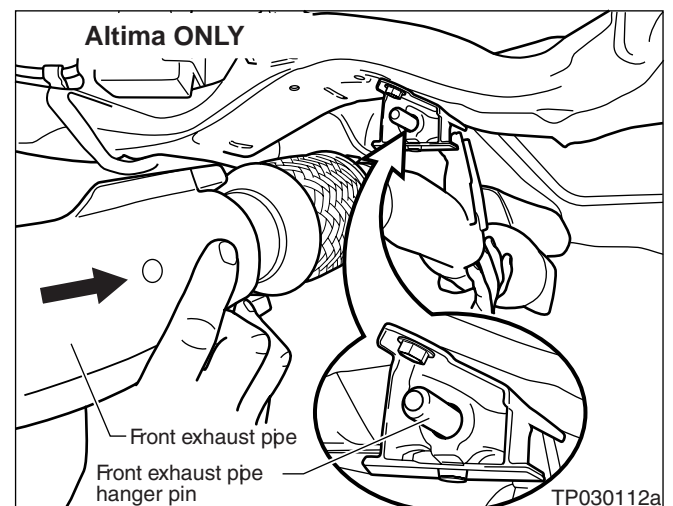
Figure 3

3. Slide the front exhaust pipe hanger pin out of the front exhaust pipe hanger (see Figure 3).
4. Remove the exhaust pipe from the vehicle.
